**FORESTDALE POND DAM
RI 02504**

**PHASE 1 INSPECTION REPORT
NATIONAL DAM INSPECTION PROGRAM**

**DEPARTMENT OF THE ARMY
NEW ENGLAND DIVISION, CORPS OF ENGINEERS
WALTHAM, MASS**

JUNE 1980

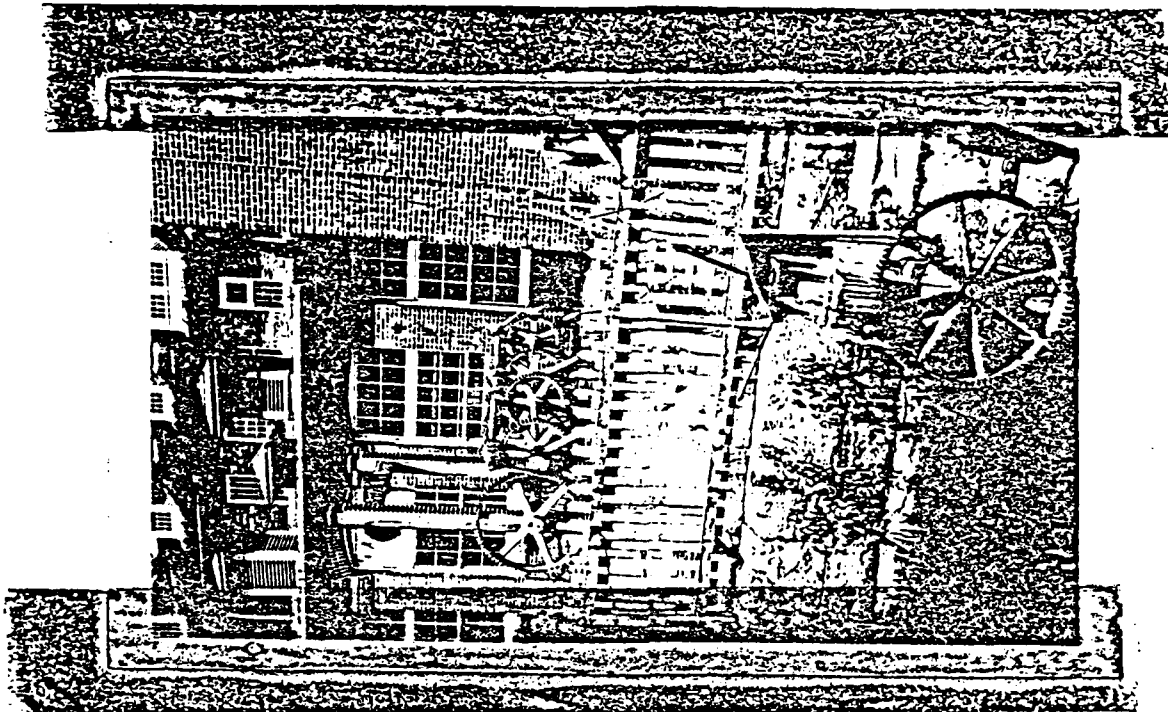
48 FORESTDALE - FROM BRIDGE OVER SPILLWAY LOOKING NORTH - SHOW WHEEL TO DRAW-OFF GATE IN 7/25/47
 FOREGROUND AND WHEELS TO OPERATE 3 GATES TO MILL (1 UP) AT REAR.

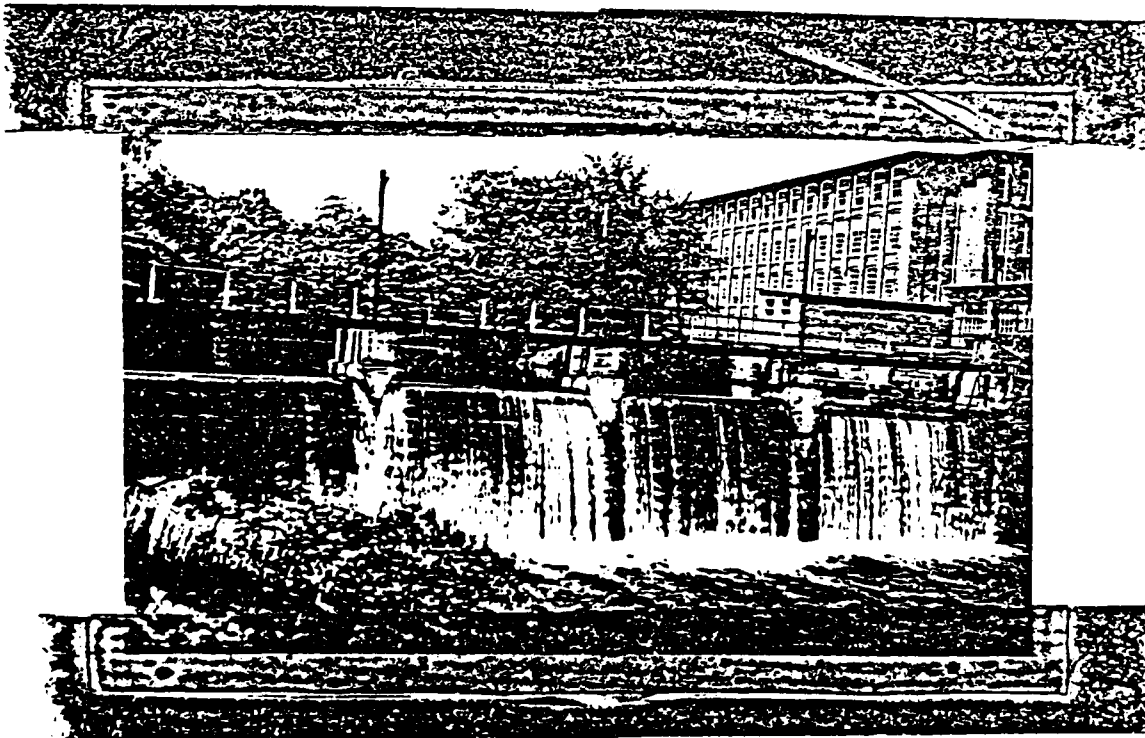
48 FORESTDALE - FROM BELOW FALLS LOOKING AT SPILLWAY WITH 2 FLASH-BOARDS IN PLACE TO-DAY. 7/25/47

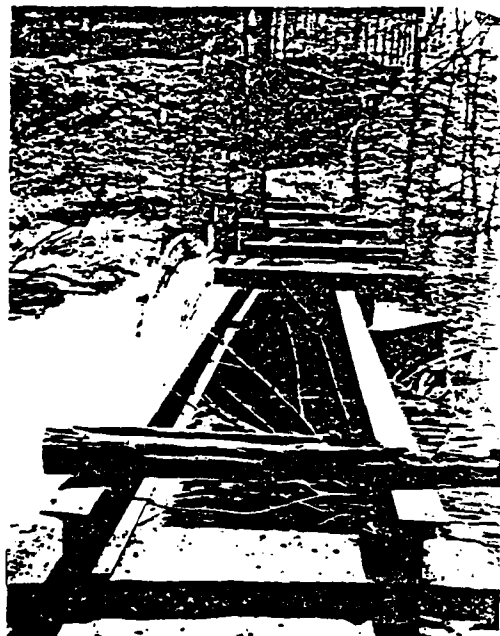
PHOTO #3

ROTATING TIMBERS @ MAIN SPILLWAY

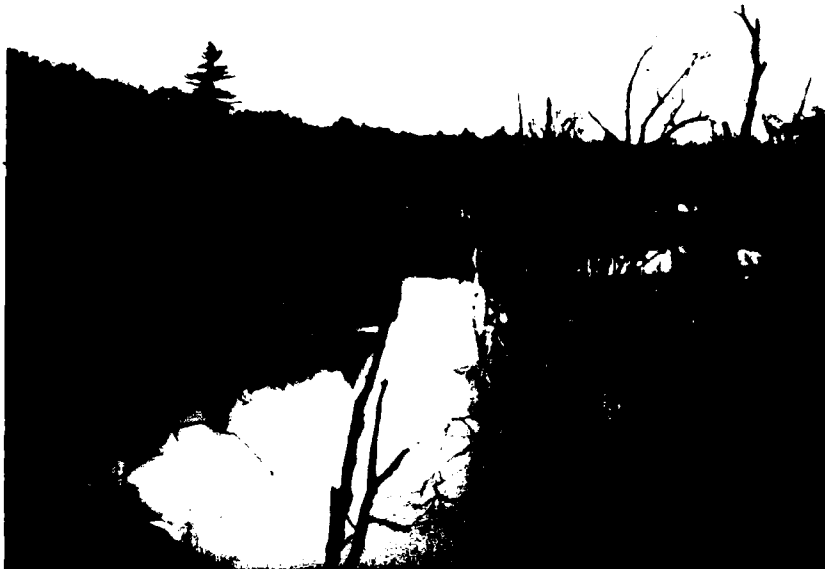
PHOTO C-9 Upstream Reservoir impounded by dam.
